**Flood Control Project Maintenance  
Levee Inspections**

**Fall 2013 Levee Maintenance Deficiency Summary Report**

**San Joaquin River Basin**

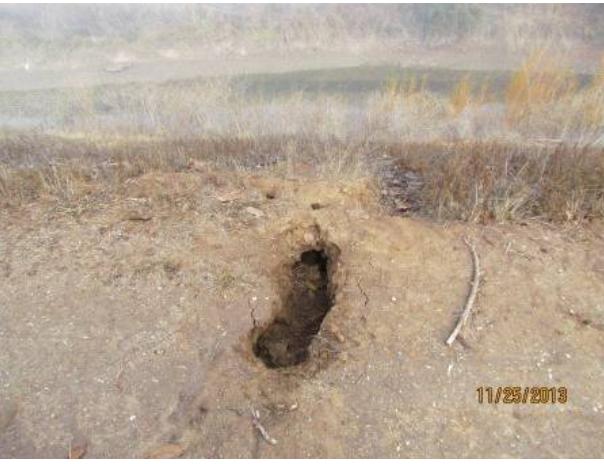
pkazi\_f\_20131126\_087.JPG

Levee Mile Report Line	93
Start Levee Mile	8.94
End Levee Mile	8.94
Location	Water Side
Category	Earthen Levee
Item	Animal Control

A collapsed animal hole was found on the waterside shoulder of the levee looking upstream.

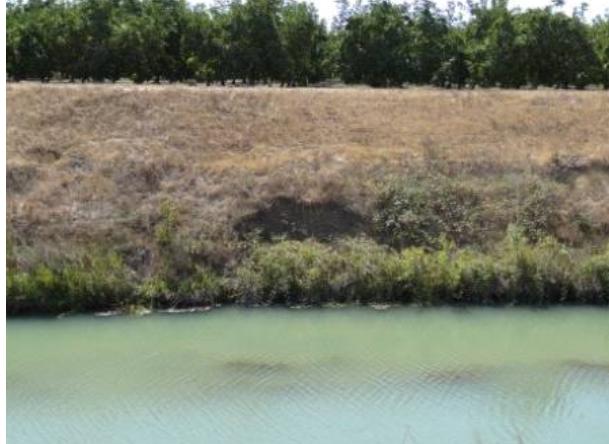
SJR2013\_NA0017U16RM13.86\_1.jpg

Levee Mile Report Line	94
Start Levee Mile	8.99
End Levee Mile	8.99
Location	Water Side
Category	Supplemental
Item	DWR Erosion Survey

Front view of erosion.

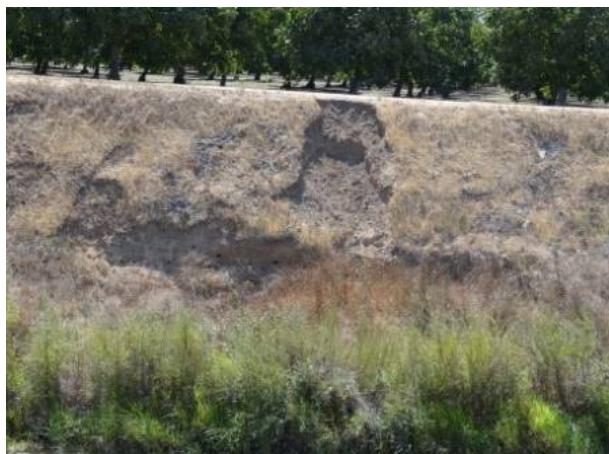
SJR2013\_NA0017U16RM13.85\_1.jpg

Levee Mile Report Line	95
Start Levee Mile	9.07
End Levee Mile	9.07
Location	Water Side
Category	Supplemental
Item	DWR Erosion Survey

Looking at the site from right river bank.

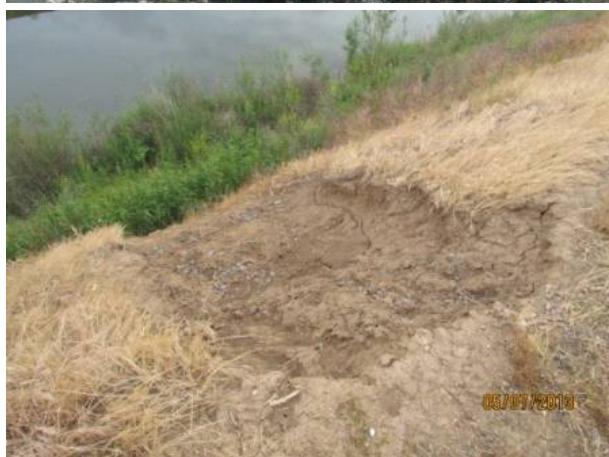
pkazi\_f\_20131001\_468.JPG

Levee Mile Report Line	96
Start Levee Mile	9.27
End Levee Mile	9.27
Location	Water Side
Category	Earthen Levee
Item	Erosion / Bank Caving

Erosion was found on the waterside slope of the levee looking upstream.

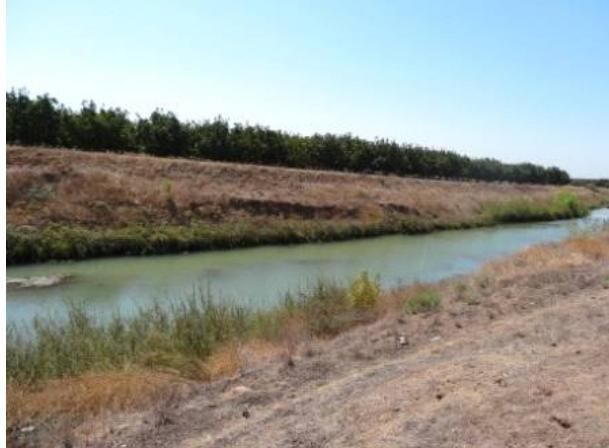
SJR2013_NA0017U16RM13.72_1.jpg

Levee Mile Report Line	97
Start Levee Mile	9.39
End Levee Mile	9.41
Location	Water Side
Category	Supplemental
Item	DWR Erosion Survey
Looking downstream at the erosion.

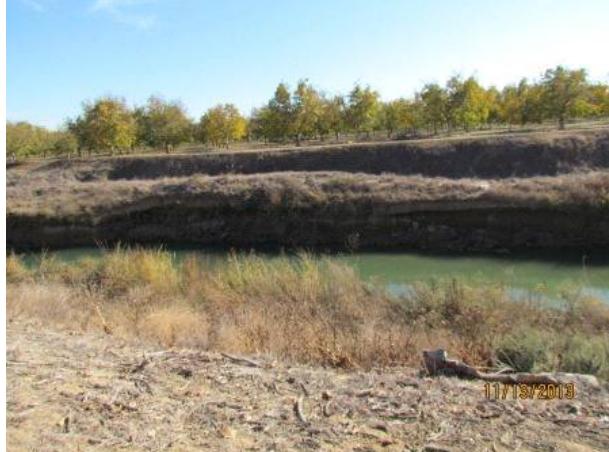
pkazi_f_20131119_059.JPG

Levee Mile Report Line	98
Start Levee Mile	9.45
End Levee Mile	9.45
Location	Water Side
Category	Earthen Levee
Item	Erosion / Bank Caving
View of the erosion on the waterside toe of the levee looking from the opposite side of the levee.

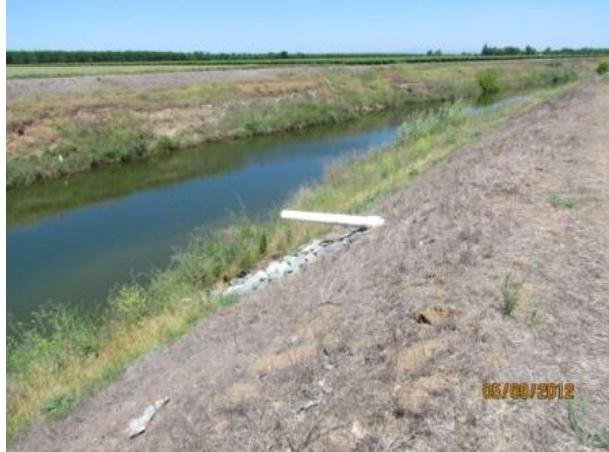
pkazi_f_20131001_485.jpg

Levee Mile Report Line	99
Start Levee Mile	9.50
End Levee Mile	9.50
Location	Water Side
Category	Earthen Levee
Item	Encroachments
A PVC pipe was found on the waterside slope of the levee looking upstream.

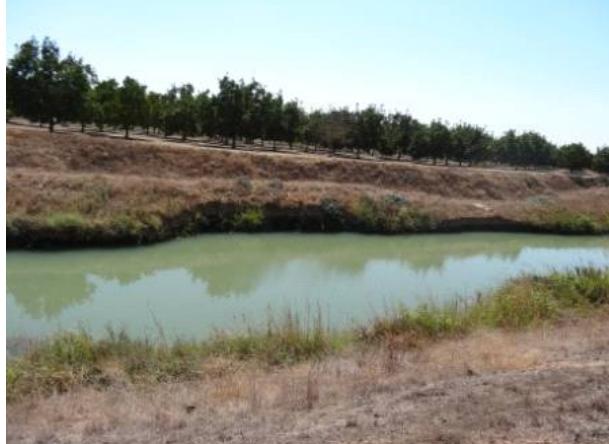
SJR2013_NA0017U16RM13.53_1.jpg

Levee Mile Report Line	100
Start Levee Mile	9.58
End Levee Mile	9.60
Location	Water Side
Category	Supplemental
Item	DWR Erosion Survey
Looking downstream at the erosion.

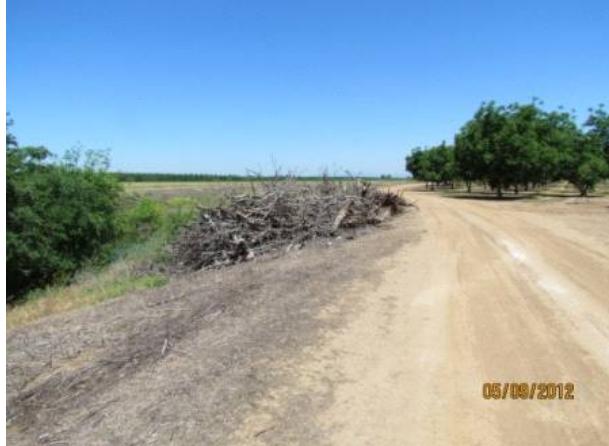
pkazi_f_20131001_427.jpg

Levee Mile Report Line	101
Start Levee Mile	9.64
End Levee Mile	9.64
Location	Water Side
Category	Earthen Levee
Item	Encroachments
Prunings were found on the waterside of the levee looking upstream.

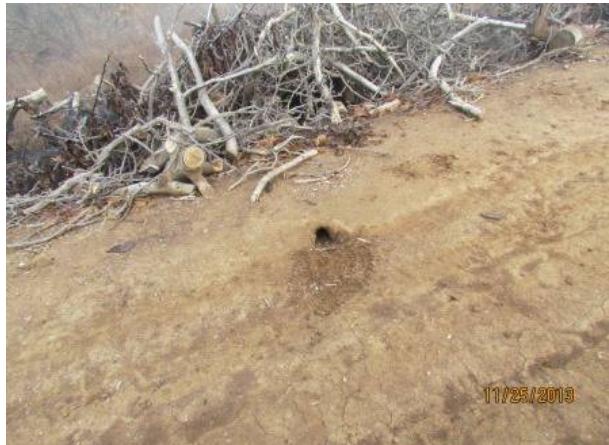
pkazi_f_20131126_086.JPG

Levee Mile Report Line	102
Start Levee Mile	9.64
End Levee Mile	9.64
Location	Water Side
Category	Earthen Levee
Item	Animal Control
A rodent hole was found on the waterside shoulder of the levee looking upstream.

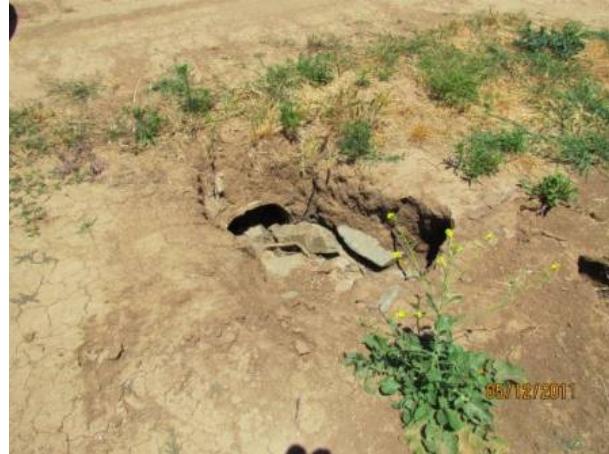
Levee Mile Report Line	103
Start Levee Mile	9.77
End Levee Mile	9.77
Location	Land Side
Category	Earthen Levee
Item	Encroachments
An abandon pipe was left by the farmer. The picture was taken from the toe of the landside of the levee looking upstream.	
pkazi_f_20131001_507.jpg

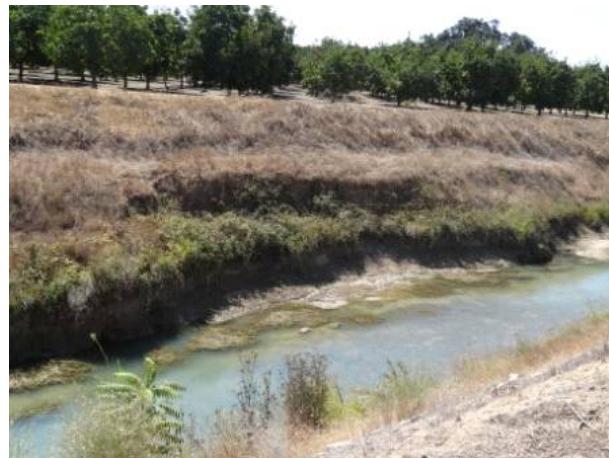
Levee Mile Report Line	104
Start Levee Mile	10.16
End Levee Mile	10.18
Location	Water Side
Category	Supplemental
Item	DWR Erosion Survey
Front view of erosion.	
SJR2013_NA0017U16RM12.95_4.jpg

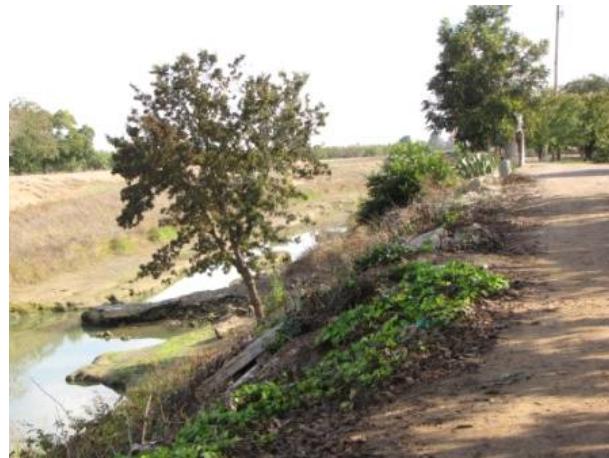
Levee Mile Report Line	108
Start Levee Mile	10.84
End Levee Mile	10.88
Location	Water Side
Category	Earthen Levee
Item	Vegetation
View of landscaping on waterward side looking upstream.	
pkazi_f_20131001_492.jpg

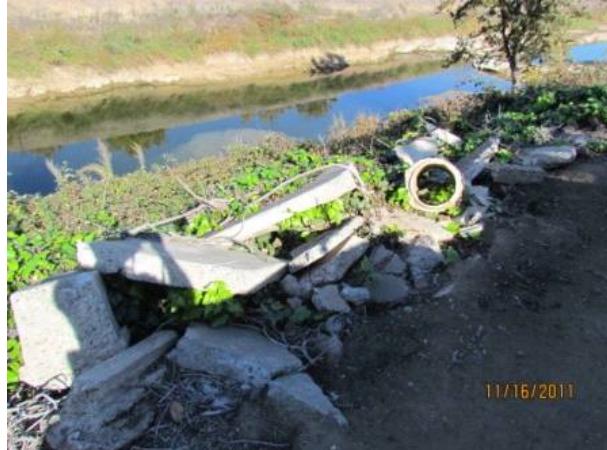
Levee Mile Report Line	109
Start Levee Mile	10.87
End Levee Mile	10.87
Location	Water Side
Category	Earthen Levee
Item	Encroachments
Concrete debris was found on the waterside of the levee looking upstream.	
pkazi_f_20131001_556.jpg

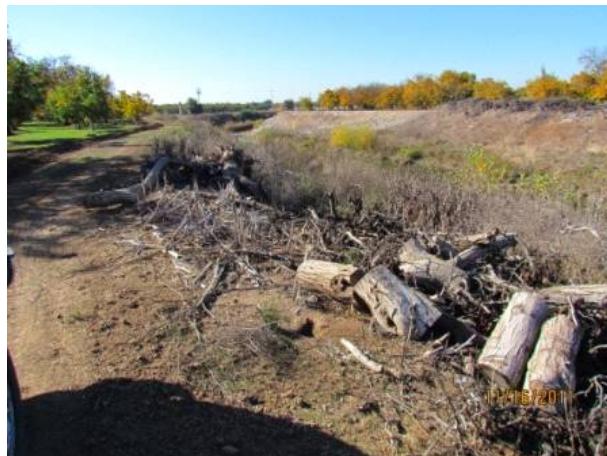
Levee Mile Report Line	111
Start Levee Mile	11.07
End Levee Mile	11.07
Location	Water Side
Category	Earthen Levee
Item	Encroachments
Prunings were found on the waterside of the levee looking downstream.	
pkazi_f_20131001_441.jpg

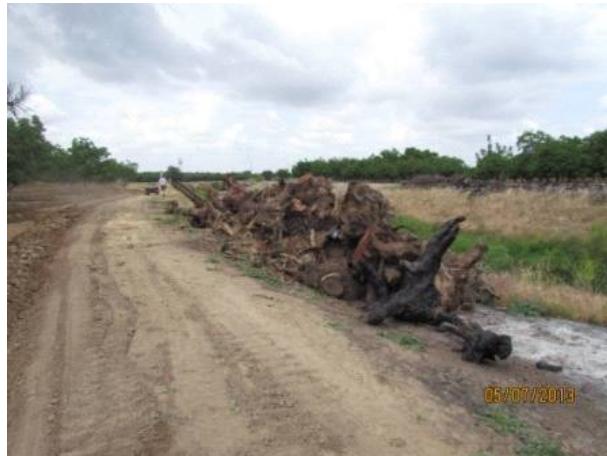
Levee Mile Report Line	111
Start Levee Mile	11.07
End Levee Mile	11.07
Location	Water Side
Category	Earthen Levee
Item	Encroachments
Prunings were found on the waterside shoulder of the levee looking downstream.	
pkazi_f_20131001_442.JPG

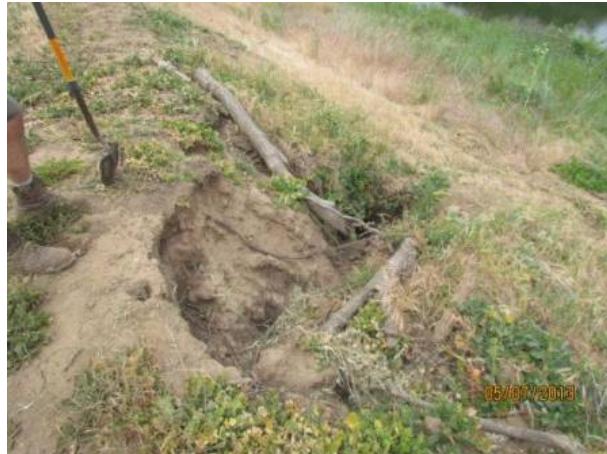
Levee Mile Report Line	112
Start Levee Mile	11.11
End Levee Mile	11.11
Location	Water Side
Category	Earthen Levee
Item	Erosion / Bank Caving
Erosion was found on the waterside of the levee looking downstream.	
pkazi_f_20131001_477.JPG

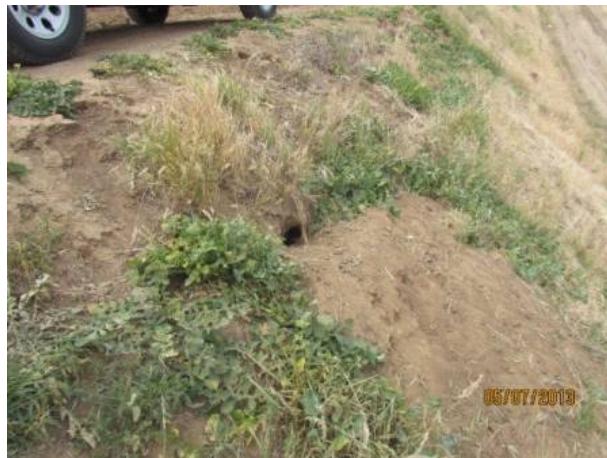
Levee Mile Report Line	113
Start Levee Mile	11.16
End Levee Mile	11.16
Location	Water Side
Category	Earthen Levee
Item	Animal Control
An animal hole was found on the waterside slope of the levee looking downstream.	
pkazi_f_20131001_478.JPG

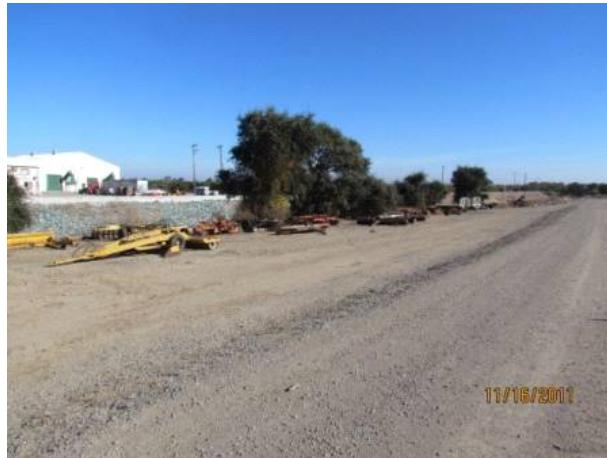
Levee Mile Report Line	114
Start Levee Mile	11.52
End Levee Mile	11.59
Location	Water Side
Category	Earthen Levee
Item	Encroachments
Equipment was found on the waterside of the levee looking upstream.	
pkazi_f_20131001_439.jpg

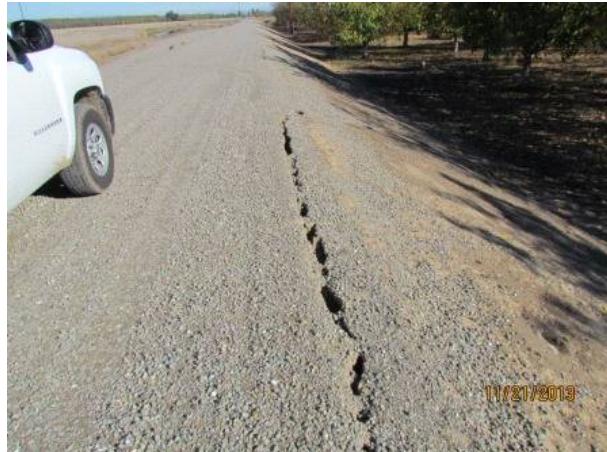
Levee Mile Report Line	117
Start Levee Mile	12.72
End Levee Mile	12.72
Location	Land Side
Category	Earthen Levee
Item	Cracking
Cracking was found on the landside shoulder of the levee looking upstream.	
pkazi_f_20131122_083.JPG

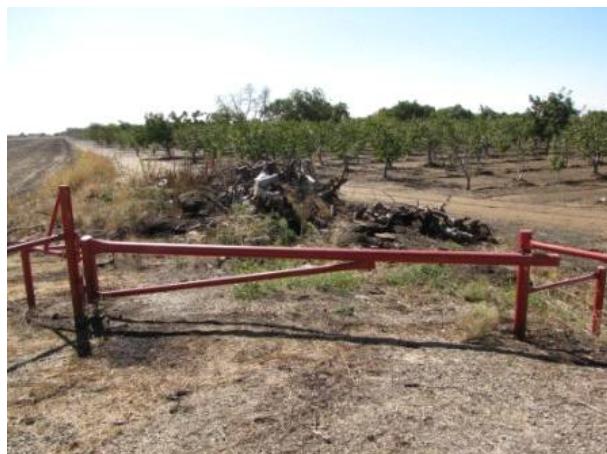
Levee Mile Report Line	118
Start Levee Mile	13.17
End Levee Mile	13.17
Location	Land Side
Category	Earthen Levee
Item	Encroachments
View of a prunings pile along the landward toe of an access ramp. Pile is blocking access through this gate.	
pkazi_f_20131001_486.jpg

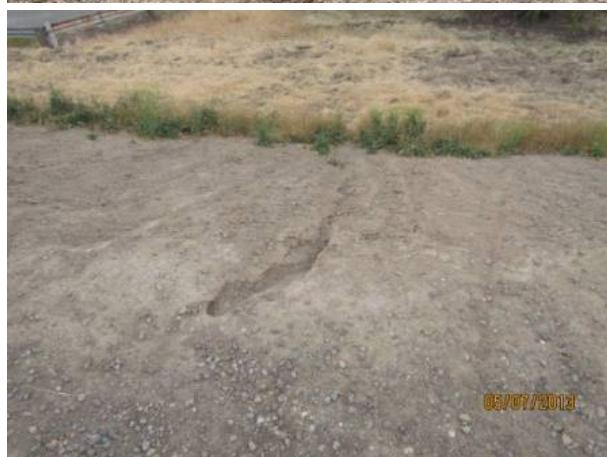
Levee Mile Report Line	119
Start Levee Mile	14.58
End Levee Mile	14.58
Location	Land Side
Category	Earthen Levee
Item	Erosion / Bank Caving
Erosion was found on the landside of the levee looking upstream.	
pkazi_f_20131001_483.JPG

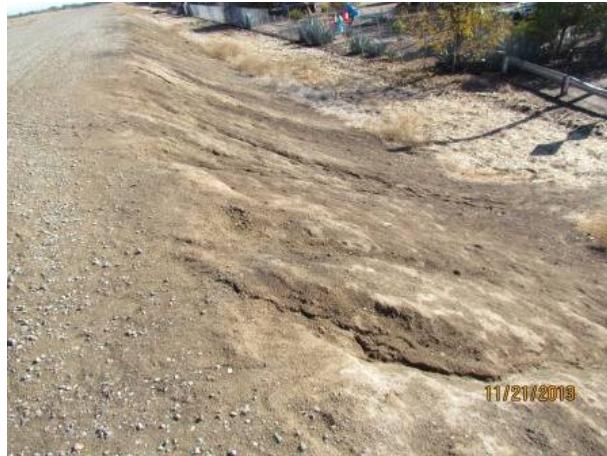
Levee Mile Report Line	119
Start Levee Mile	14.58
End Levee Mile	14.58
Location	Land Side
Category	Earthen Levee
Item	Erosion / Bank Caving
Updated picture of the erosion due to runoff on the landside of the levee looking upstream.	
pkazi_f_20131122_082.JPG

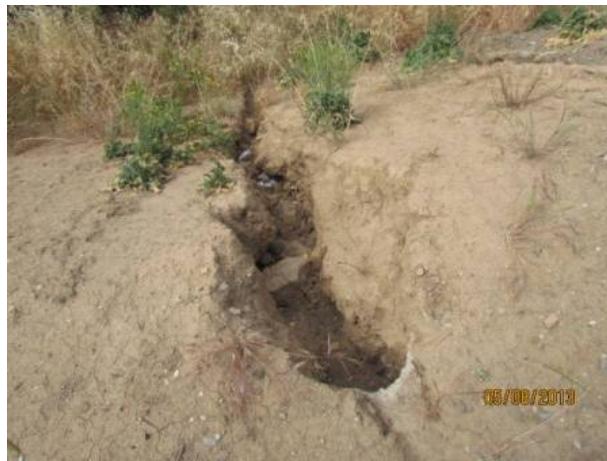
Levee Mile Report Line	123
Start Levee Mile	16.83
End Levee Mile	16.83
Location	Land Side
Category	Earthen Levee
Item	Erosion / Bank Caving
Erosion was found on the landside of the levee looking downstream.	
pkazi_f_20131001_488.JPG

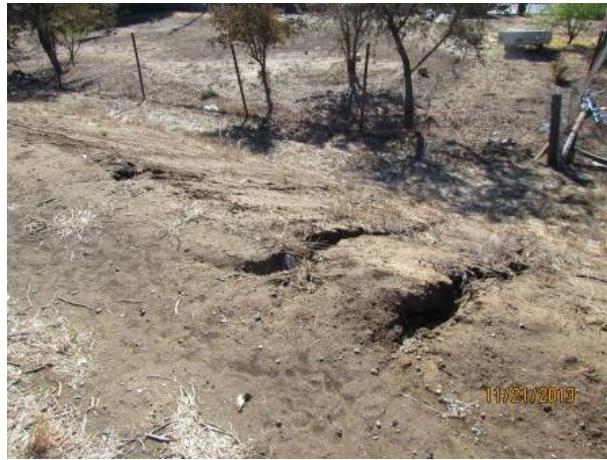
Levee Mile Report Line	124
Start Levee Mile	17.20
End Levee Mile	17.20
Location	Land Side
Category	Earthen Levee
Item	Erosion / Bank Caving
Erosion due to runoff was found on the landside slope of the levee looking upstream.	
pkazi_f_20131122_081.JPG

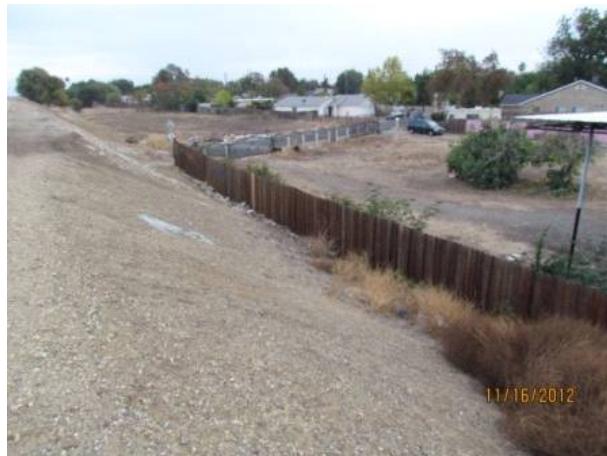
Levee Mile Report Line	125
Start Levee Mile	17.57
End Levee Mile	17.61
Location	Land Side
Category	Earthen Levee
Item	Encroachments
Fence was found on the landside toe of the levee looking upstream.	pkazi_f_20131001_432.jpg

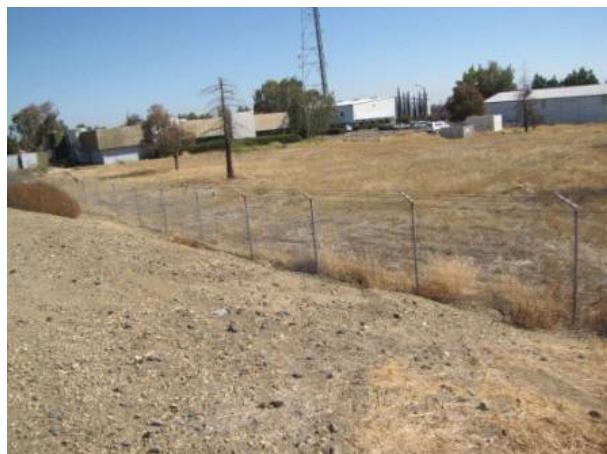
Levee Mile Report Line	126
Start Levee Mile	19.00
End Levee Mile	19.20
Location	Land Side
Category	Earthen Levee
Item	Encroachments
View of a fence along the landward toe looking upstream.	pkazi_f_20131001_481.jpg

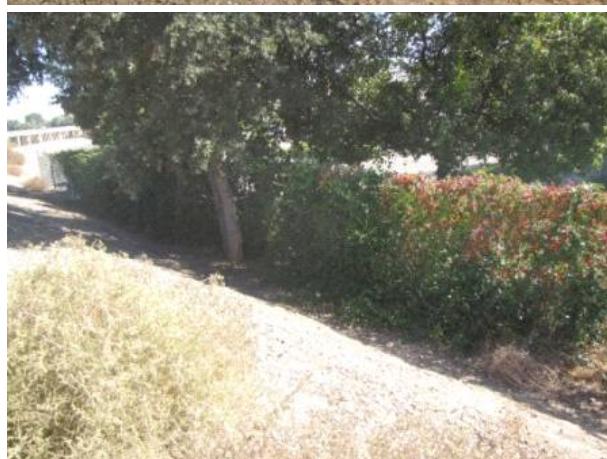
Levee Mile Report Line	127
Start Levee Mile	19.12
End Levee Mile	19.14
Location	Land Side
Category	Earthen Levee
Item	Vegetation
View of landscaping along the landward toe.	pkazi_f_20131001_482.jpg

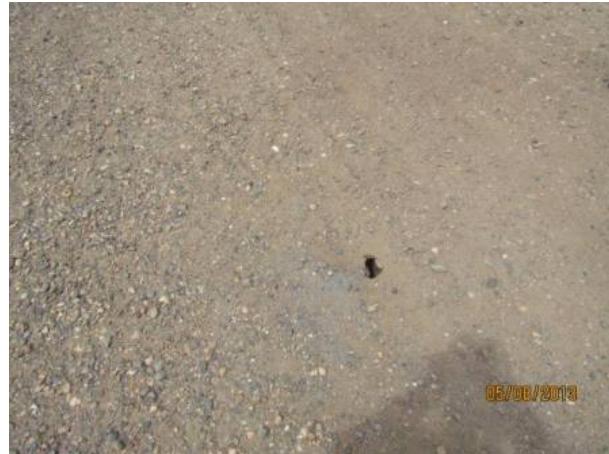
Levee Mile Report Line	128
Start Levee Mile	19.35
End Levee Mile	19.35
Location	Crown
Category	Earthen Levee
Item	Animal Control
An animal hole was found on the crown of the levee looking downstream. The hole was measured to be 3 feet deep.	
pkazi_f_20131001_489.JPG

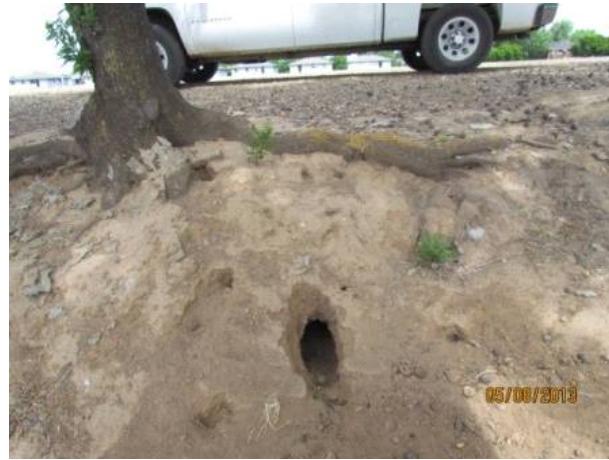
Levee Mile Report Line	130
Start Levee Mile	19.41
End Levee Mile	19.41
Location	Land Side
Category	Earthen Levee
Item	Animal Control
An animal hole was found on the landside of the levee looking towards the crown.	
pkazi_f_20131001_491.JPG

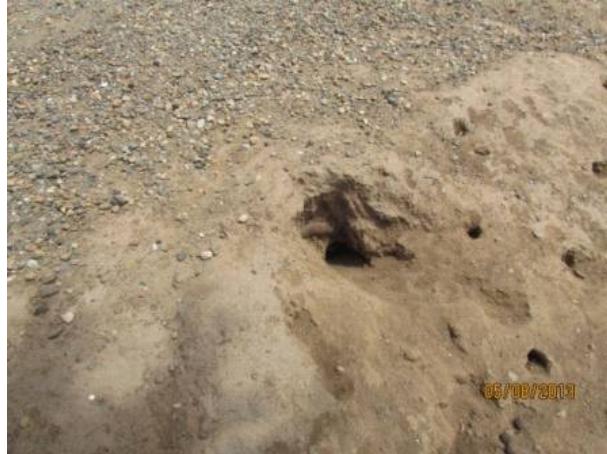
Levee Mile Report Line	131
Start Levee Mile	19.42
End Levee Mile	19.42
Location	Land Side
Category	Earthen Levee
Item	Animal Control
Animal holes were found on the landside of the levee looking upstream.	
pkazi_f_20131001_493.JPG

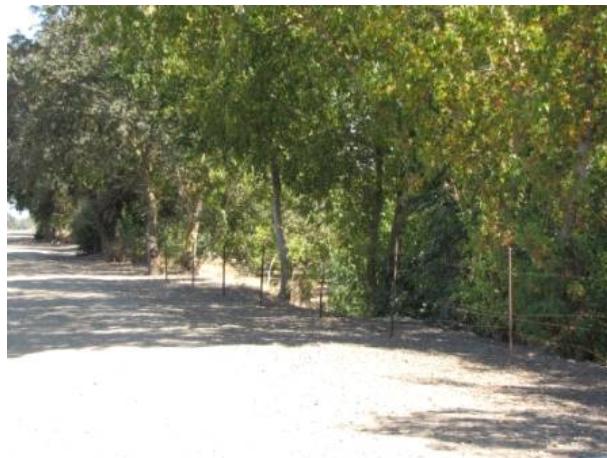
Levee Mile Report Line	132
Start Levee Mile	19.47
End Levee Mile	19.60
Location	Land Side
Category	Earthen Levee
Item	Encroachments
View of a barbed wire fence and landscaping along the landward shoulder and slope looking upstream.	
pkazi_f_20131001_475.jpg

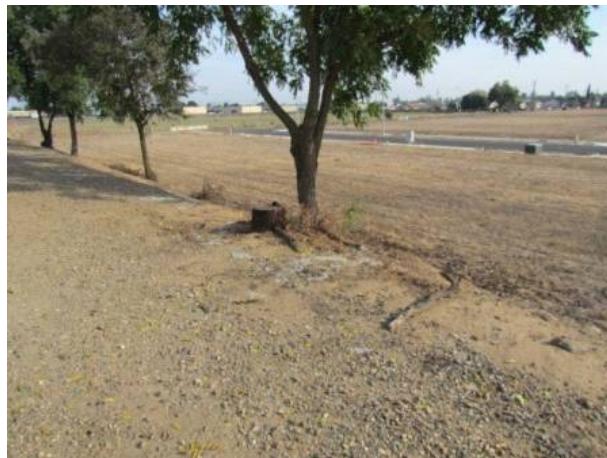
Levee Mile Report Line	133
Start Levee Mile	19.48
End Levee Mile	19.48
Location	Land Side
Category	Earthen Levee
Item	Trim / Thin Trees
Tree stump was found on the landside of the levee looking upstream.	
pkazi_f_20131001_428.jpg

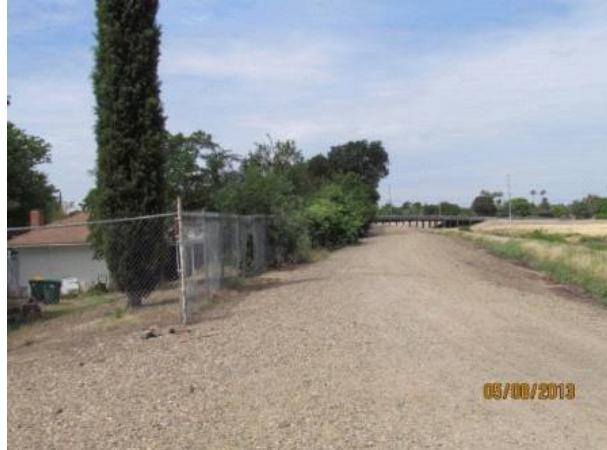
Levee Mile Report Line	134
Start Levee Mile	19.60
End Levee Mile	19.68
Location	Land Side
Category	Earthen Levee
Item	Vegetation
View of the landscaping on the landside shoulder of the levee looking downstream.	
pkazi_f_20131001_474.JPG

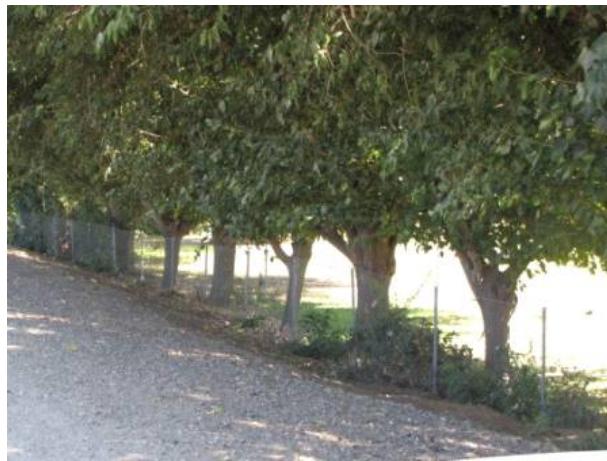
Levee Mile Report Line	135
Start Levee Mile	19.60
End Levee Mile	19.69
Location	Land Side
Category	Earthen Levee
Item	Encroachments
View of a fence along the landward slope looking upstream.	
pkazi_f_20131001_473.jpg

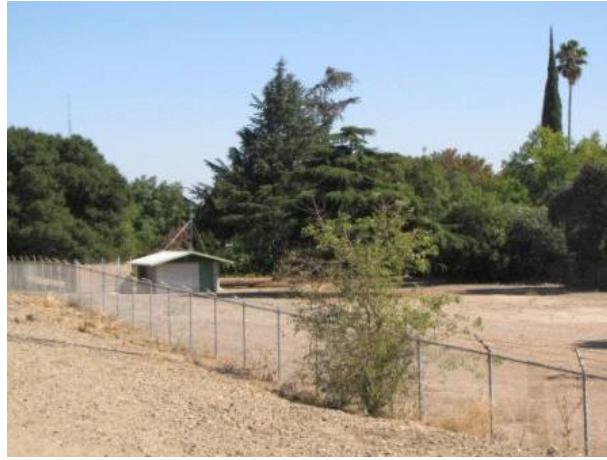
Levee Mile Report Line	136
Start Levee Mile	19.82
End Levee Mile	19.90
Location	Land Side
Category	Earthen Levee
Item	Encroachments
View of a fence along the landward toe looking upstream.	
pkazi_f_20131001_472.jpg

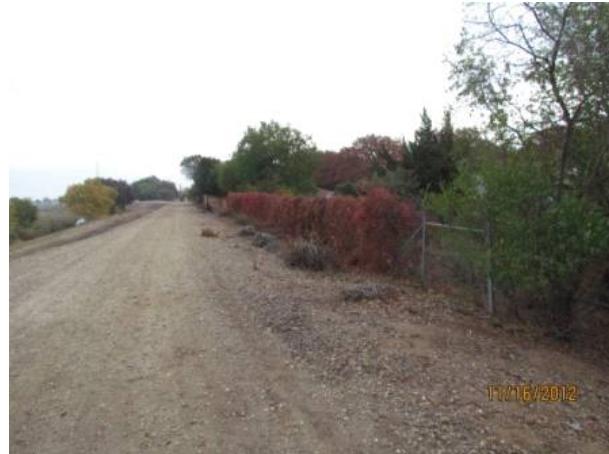
Levee Mile Report Line	137
Start Levee Mile	19.83
End Levee Mile	19.83
Location	Land Side
Category	Earthen Levee
Item	Vegetation
Landscaping was found on the landside shoulder of the levee looking upstream.	
<i>pkazi_f_20131001_407.jpg</i>

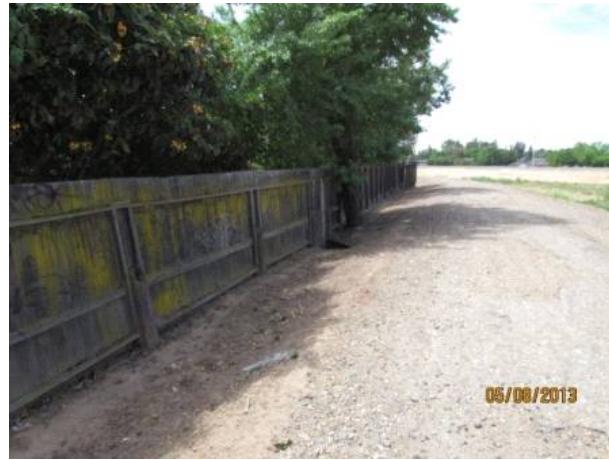
Levee Mile Report Line	140
Start Levee Mile	20.04
End Levee Mile	20.04
Location	Land Side
Category	Earthen Levee
Item	Encroachments
Fences were obstructing the landside slope of the levee looking downstream.	
<i>pkazi_f_20131001_436.JPG</i>

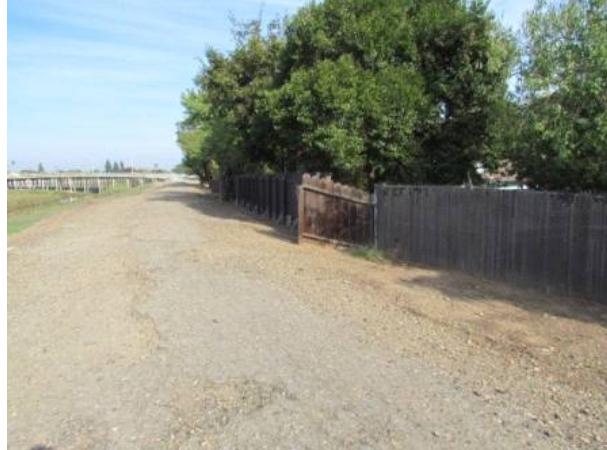
Levee Mile Report Line	141
Start Levee Mile	20.05
End Levee Mile	20.05
Location	Land Side
Category	Earthen Levee
Item	Encroachments
Wooden fence on the landside of the levee looking upstream.	
pkazi_f_20131001_406.jpg

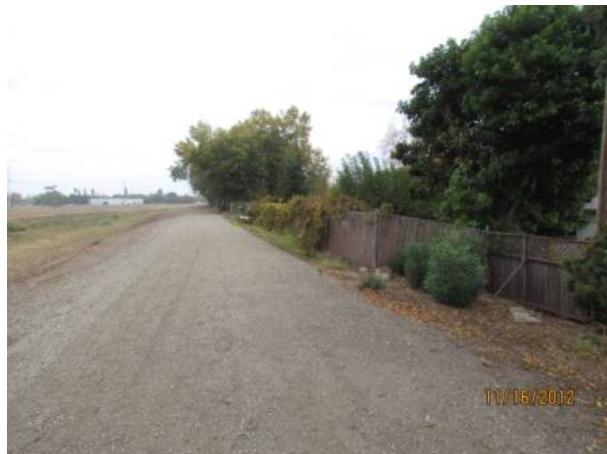
Levee Mile Report Line	150
Start Levee Mile	20.23
End Levee Mile	20.23
Location	Land Side
Category	Earthen Levee
Item	Encroachments
A fence was found on the landside shoulder of the levee looking upstream.	
pkazi_f_20131001_405.jpg

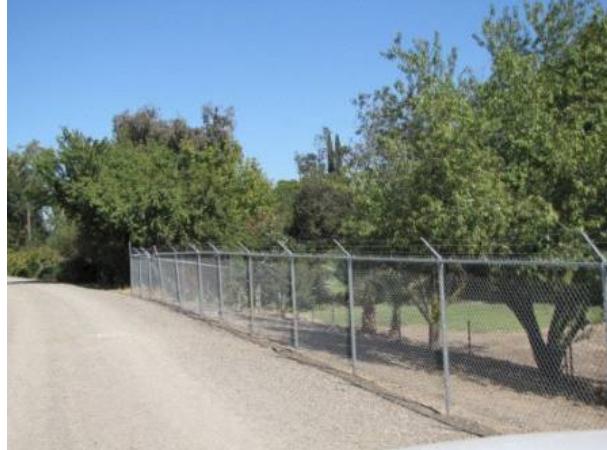
Levee Mile Report Line	153
Start Levee Mile	20.26
End Levee Mile	20.28
Location	Land Side
Category	Earthen Levee
Item	Encroachments
View of a fence along the landward slope looking upstream.	
pkazi_f_20131001_470.jpg

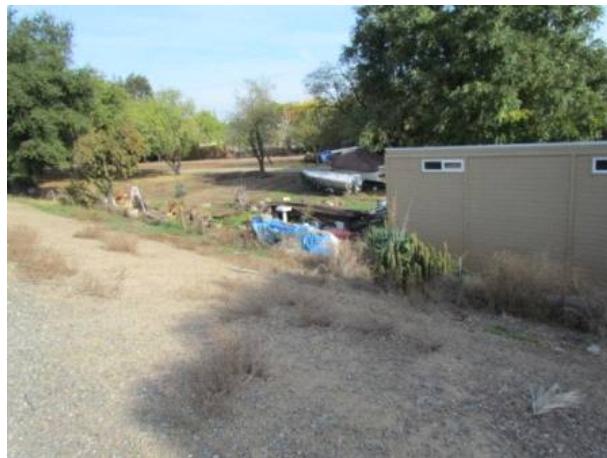
Levee Mile Report Line	154
Start Levee Mile	20.45
End Levee Mile	20.48
Location	Land Side
Category	Earthen Levee
Item	Vegetation
Landscaping was found on the toe of landside of the levee looking upstream.	
pkazi_f_20131001_503.jpg

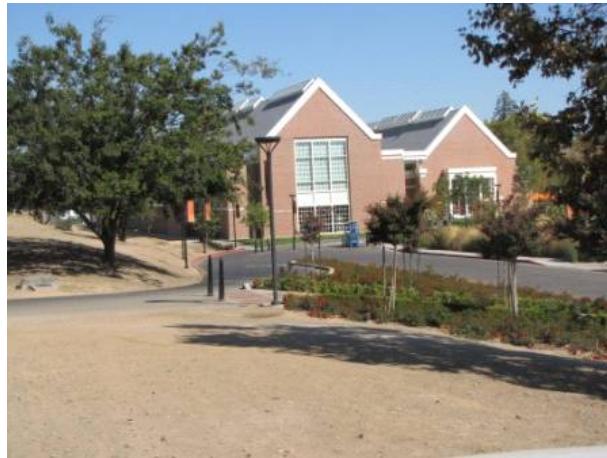
Levee Mile Report Line	155
Start Levee Mile	20.83
End Levee Mile	20.83
Location	Land Side
Category	Earthen Levee
Item	Vegetation
View of landscaping planted and maintained by UOP along the landward slope and toe looking upstream.	
pkazi_f_20131001_469.jpg

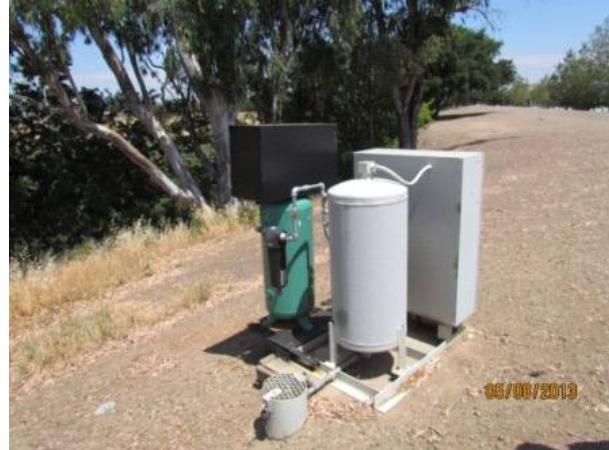
Levee Mile Report Line	156
Start Levee Mile	20.97
End Levee Mile	20.97
Location	Water Side
Category	Earthen Levee
Item	Encroachments
A compressor was found on the waterside shoulder of the levee looking upstream.	
pkazi_f_20131001_499.JPG

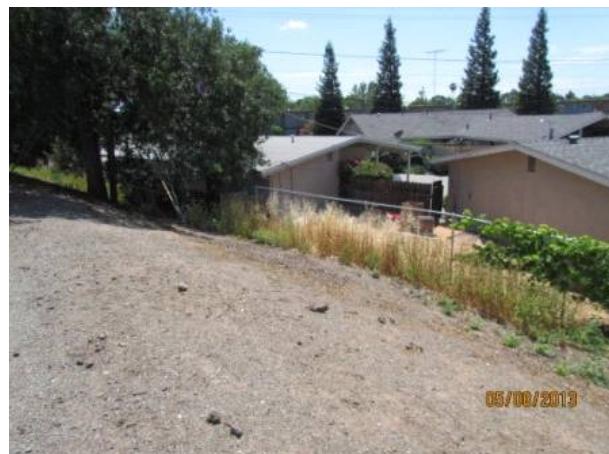
Levee Mile Report Line	159
Start Levee Mile	21.20
End Levee Mile	21.20
Location	Land Side
Category	Earthen Levee
Item	Encroachments
Fence was found on the landside toe of the levee looking upstream.	
pkazi_f_20131001_404.JPG

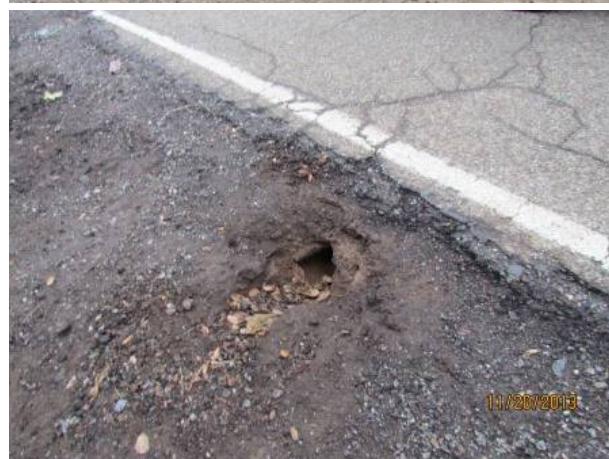
Levee Mile Report Line	161
Start Levee Mile	21.29
End Levee Mile	21.29
Location	Land Side
Category	Earthen Levee
Item	Animal Control
An animal hole was found on the landside shoulder of the levee looking downstream.	
pkazi_f_20131122_080.JPG

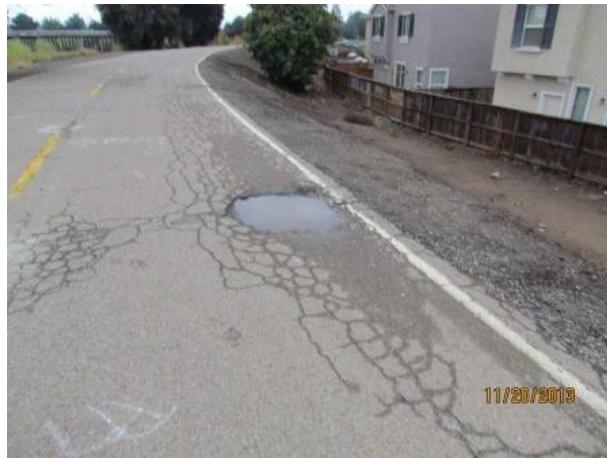
Levee Mile Report Line	163
Start Levee Mile	21.31
End Levee Mile	21.31
Location	Crown
Category	Earthen Levee
Item	Crown Surface / Depressions / Rutting
Crown depression was found on the levee looking upstream.	
pkazi_f_20131122_079.JPG

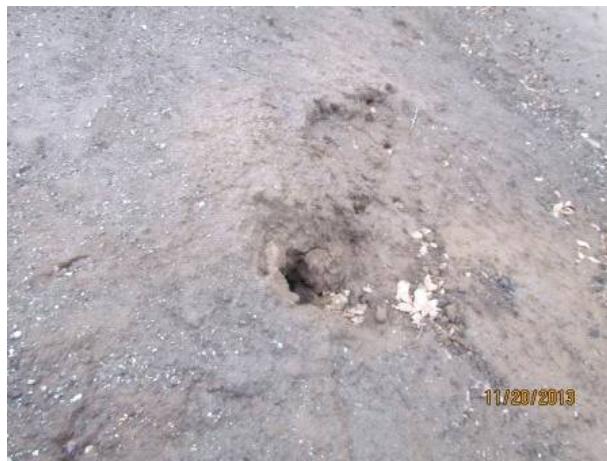
Levee Mile Report Line	164
Start Levee Mile	21.31
End Levee Mile	21.31
Location	Land Side
Category	Earthen Levee
Item	Animal Control
A rodent hole was found on the landside of the levee looking upstream.	
pkazi_f_20131122_078.JPG

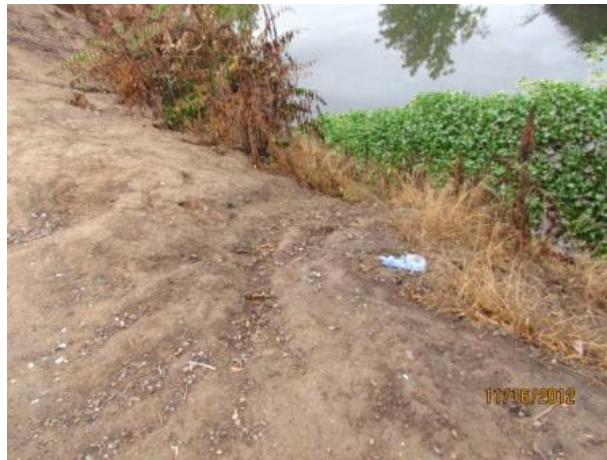
Levee Mile Report Line	165
Start Levee Mile	21.36
End Levee Mile	21.36
Location	Water Side
Category	Earthen Levee
Item	Erosion / Bank Caving
Erosion was found on the waterside shoulder of the levee looking downstream.	
pkazi_f_20131001_399.jpg

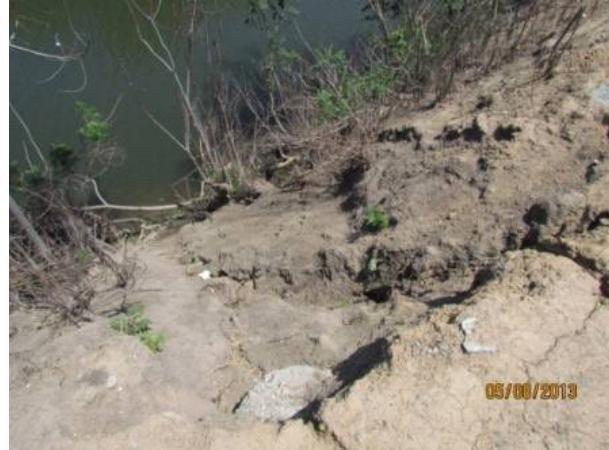
Levee Mile Report Line	166
Start Levee Mile	21.37
End Levee Mile	21.37
Location	Water Side
Category	Earthen Levee
Item	Erosion / Bank Caving
Slope instability was found on the waterside slope of the levee looking upstream.	
pkazi_f_20131001_500.JPG

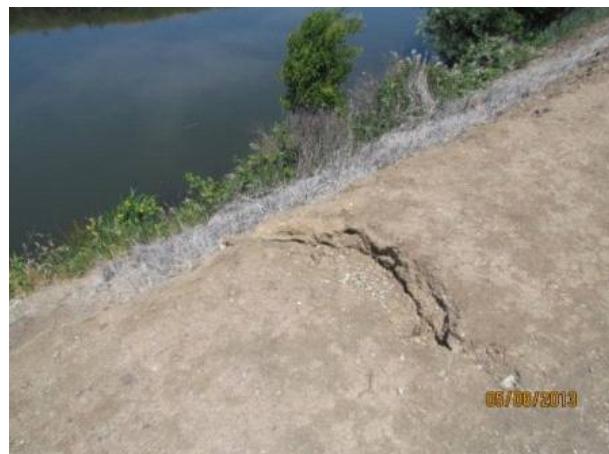
Levee Mile Report Line	167
Start Levee Mile	21.44
End Levee Mile	21.44
Location	Water Side
Category	Earthen Levee
Item	Erosion / Bank Caving
Erosion was found on the waterside slope of the levee looking upstream.	
pkazi_f_20131001_510.JPG

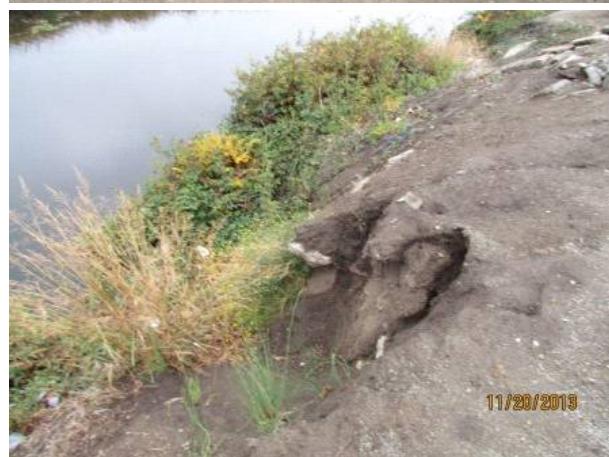
Levee Mile Report Line	168
Start Levee Mile	21.52
End Levee Mile	21.52
Location	Water Side
Category	Earthen Levee
Item	Erosion / Bank Caving
Erosion was found on the waterside of the levee looking upstream.	
pkazi_f_20131122_077.JPG

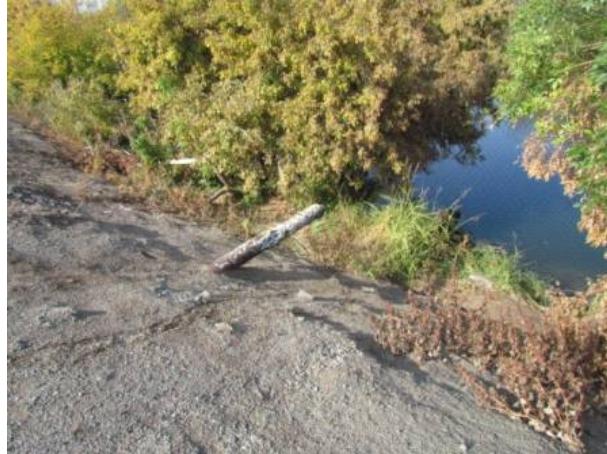
Levee Mile Report Line	169
Start Levee Mile	21.54
End Levee Mile	21.54
Location	Water Side
Category	Earthen Levee
Item	Encroachments
An abandoned pipe was found on the waterside of the levee looking downstream.	
pkazi_f_20131001_554.jpg

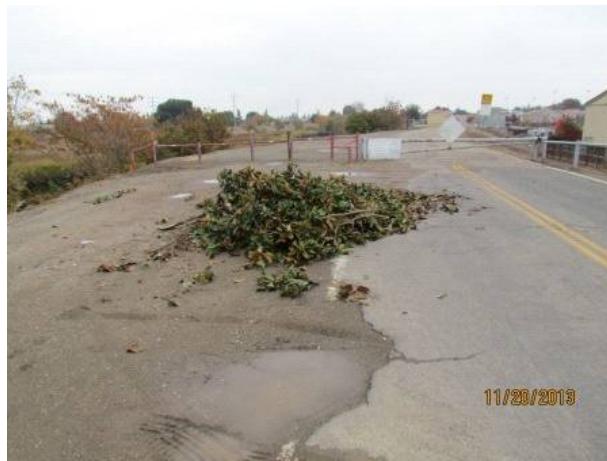
Levee Mile Report Line	170
Start Levee Mile	21.54
End Levee Mile	21.54
Location	Water Side
Category	Earthen Levee
Item	Encroachments
Prunings were found on the waterside shoulder of the levee looking upstream.	
pkazi_f_20131122_076.JPG

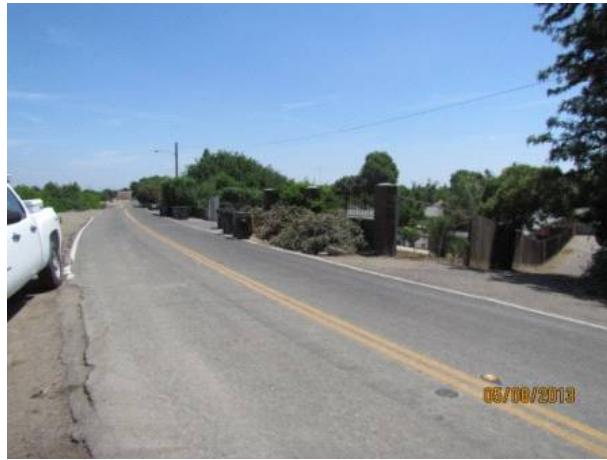
Levee Mile Report Line	173
Start Levee Mile	21.64
End Levee Mile	21.64
Location	Land Side
Category	Earthen Levee
Item	Vegetation
Landscaping was found on the landside of the levee looking upstream.	
pkazi_f_20131001_403.JPG

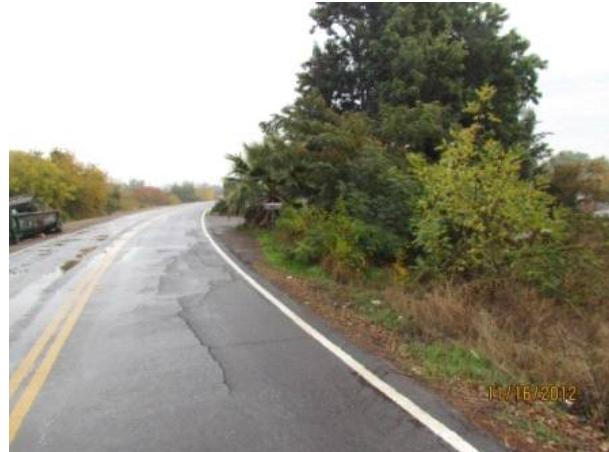
Levee Mile Report Line	174
Start Levee Mile	21.71
End Levee Mile	21.71
Location	Land Side
Category	Earthen Levee
Item	Vegetation
Landscaping was found on the landside shoulder of the levee looking upstream.	
pkazi_f_20131001_402.jpg

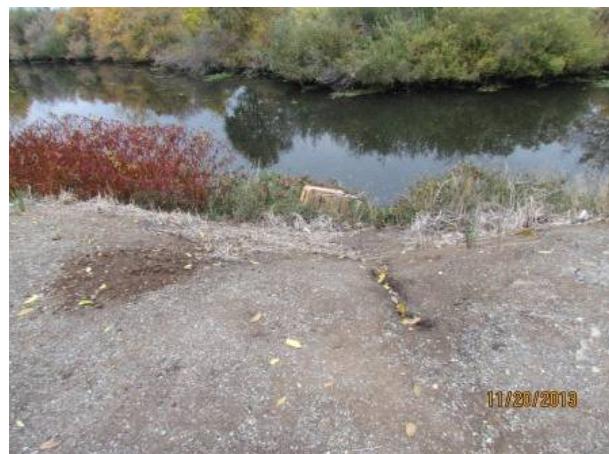
Levee Mile Report Line	176
Start Levee Mile	21.78
End Levee Mile	21.78
Location	Water Side
Category	Earthen Levee
Item	Erosion / Bank Caving
Erosion due to runoff was found on the waterside of the levee looking upstream.	
pkazi_f_20131122_075.JPG

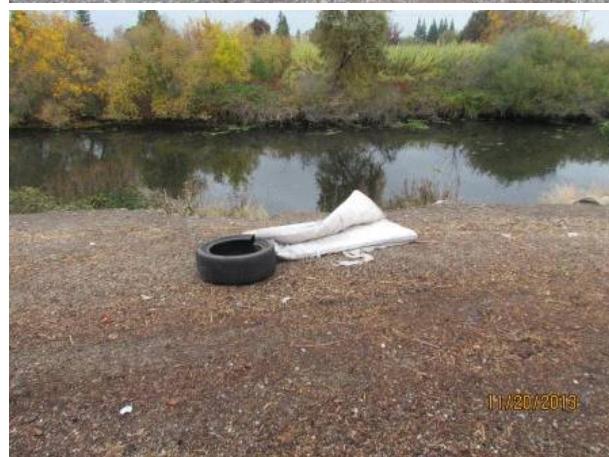
Levee Mile Report Line	178
Start Levee Mile	21.83
End Levee Mile	21.83
Location	Water Side
Category	Earthen Levee
Item	Encroachments
Debris was found on the waterside shoulder of the levee looking upstream.	
pkazi_f_20131122_074.JPG

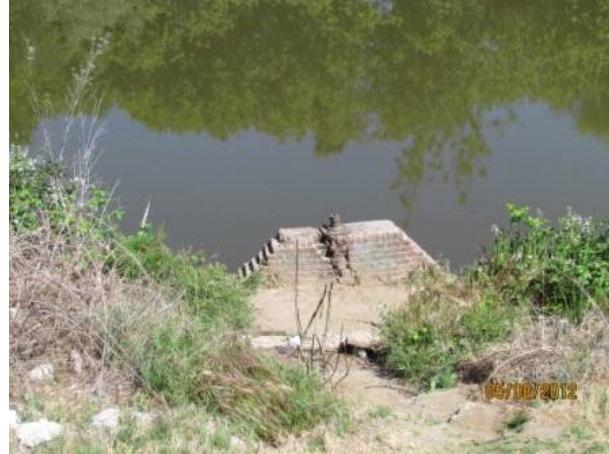
Levee Mile Report Line	179
Start Levee Mile	21.84
End Levee Mile	21.84
Location	Water Side
Category	Earthen Levee
Item	Encroachments
A retaining wall was found on the waterside toe of the levee looking upstream.	
pkazi_f_20131001_430.jpg

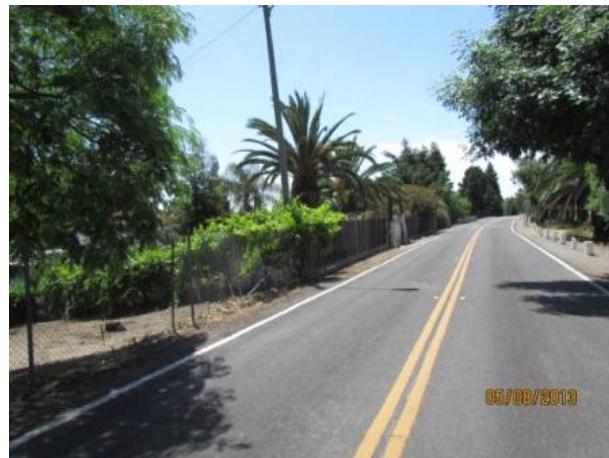
Levee Mile Report Line	182
Start Levee Mile	21.90
End Levee Mile	21.90
Location	Water Side
Category	Earthen Levee
Item	Vegetation
Landscaping was found on the landside of the levee looking downstream.	
pkazi_f_20131001_400.JPG

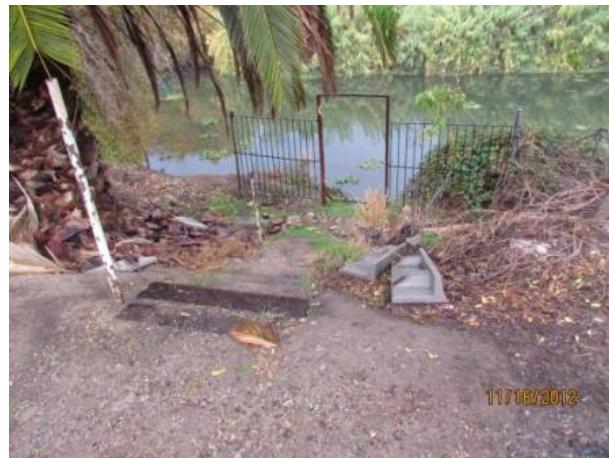
Levee Mile Report Line	183
Start Levee Mile	21.91
End Levee Mile	21.91
Location	Water Side
Category	Earthen Levee
Item	Encroachments
Stairs and fence were located on the waterside slope of the levee looking downstream.	
pkazi_f_20131001_394.jpg

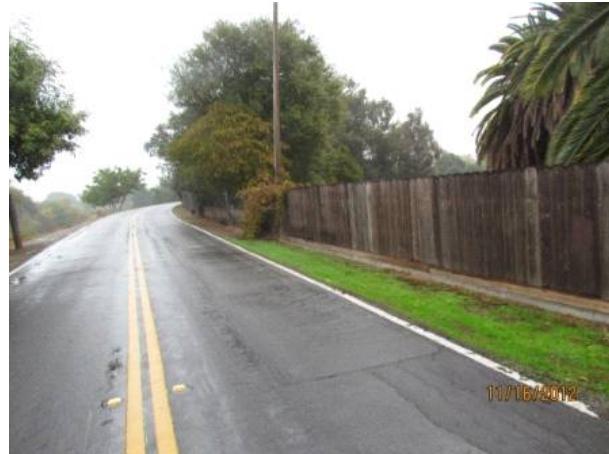
Levee Mile Report Line	184
Start Levee Mile	21.91
End Levee Mile	21.91
Location	Land Side
Category	Earthen Levee
Item	Encroachments
A fence was found on the landside shoulder of the levee looking upstream.	
pkazi_f_20131001_397.jpg

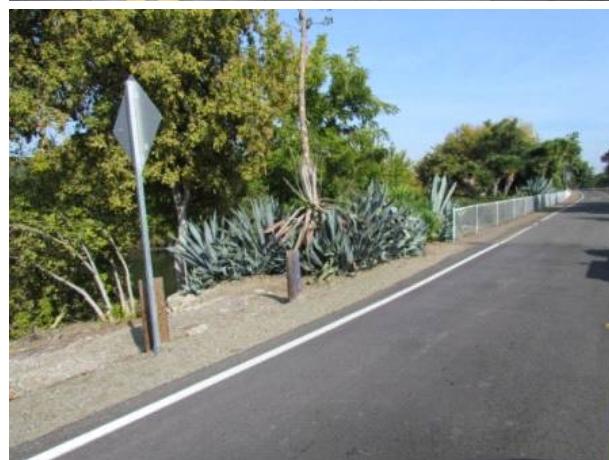
Levee Mile Report Line	185
Start Levee Mile	21.97
End Levee Mile	21.97
Location	Water Side
Category	Earthen Levee
Item	Vegetation
View of landscaping on the waterside of the levee looking upstream.	
pkazi_f_20131001_396.jpg

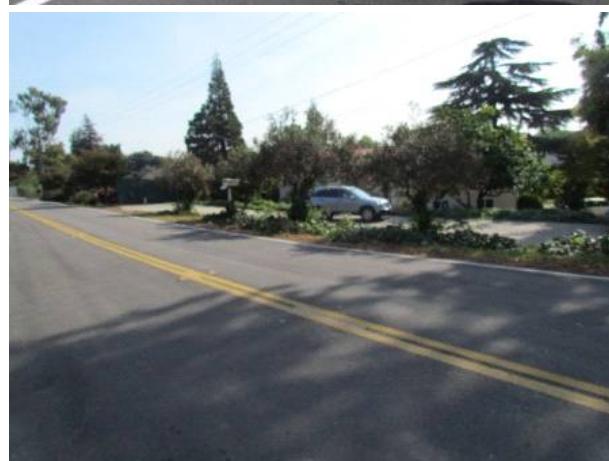
Levee Mile Report Line	186
Start Levee Mile	22.08
End Levee Mile	22.08
Location	Land Side
Category	Earthen Levee
Item	Vegetation
View of the landscape on the landside of the levee looking upstream.	
pkazi_f_20131001_393.jpg

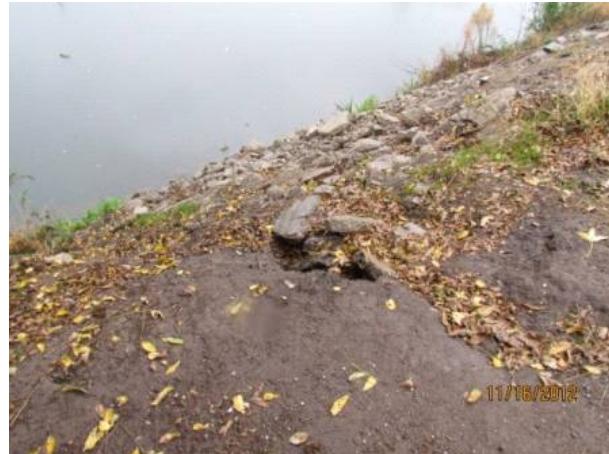
Levee Mile Report Line	189
Start Levee Mile	22.15
End Levee Mile	22.15
Location	Water Side
Category	Earthen Levee
Item	Erosion / Bank Caving
Erosion was found on the waterside slope of the levee looking upstream.	
pkazi_f_20131001_431.jpg

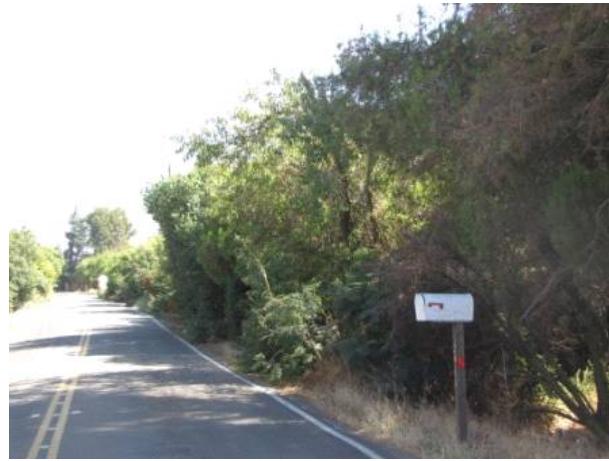
Levee Mile Report Line	190
Start Levee Mile	22.17
End Levee Mile	22.37
Location	Land Side
Category	Earthen Levee
Item	Vegetation
View of landscaping along landward slope looking upstream.	
pkazi_f_20131001_462.jpg
